# **ON ADIABATIC SHEAR BAND DETERMINATIONS BY SURFACE OBSERVATIONS**

**MICHAEL R. STAKER**  
PROCESS DEVELOPMENT DIVISION

March 1980

**ARMY MATERIALS AND MECHANICS RESEARCH CENTER**  
Watertown, Massachusetts 02172

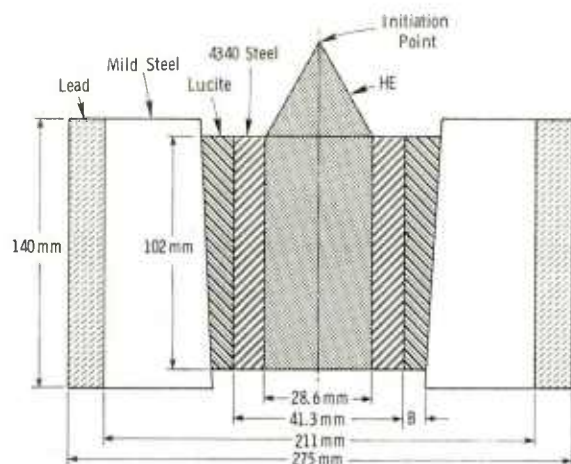
Figure 1. Cross-section diagram of contained fragmenting round experiments with 4340 steel specimen in place. The buffer layer thickness  $B$  is in the range of 1.5 mm, but varies from experiment to experiment, and may be double at the top.

This quick-stop technique is described by Erlich et al.<sup>6,7</sup> but, briefly, it consists of a large, outer thick-walled containment cylinder surrounding the hollow right cylindrical specimen which is loaded with high explosive (C-4 at a density of 1.65 g/cc) and separated from the containment cylinder by a buffer layer of a castable polymerized methyl methacrylate (Figure 1). A cast-in-place lead cylinder surrounds the containment cylinder and acts as a trap to carry momentum radially away from the specimen. The compressive wave from detonation travels outward and enters the lead cylinder, but as reflection occurs at the outer diameter of the lead cylinder, the ingoing tensile wave stretches the lead cylinder and carries momentum away, minimizing damage to the specimen. As the specimen expands, the buffer layer is compressed, preventing an impact against the containment cylinder. The thickness of the buffer layer controls the amount of radial expansion of the specimen. Use of a tapered buffer layer allows a variation in strain within one specimen.

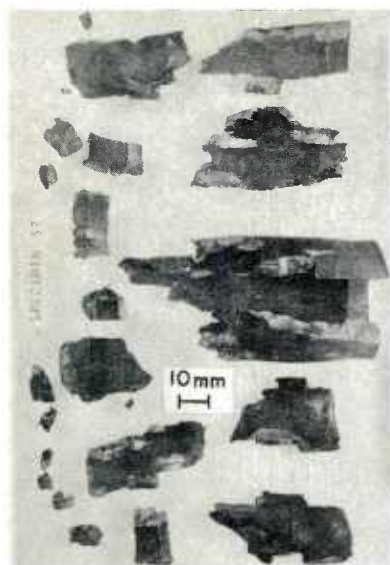
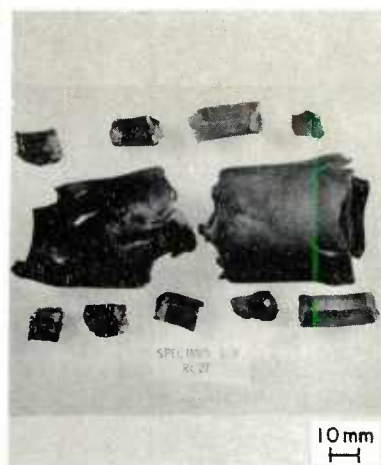
Figure 2. Specimens after detonation showing (a) each specimen post mortem and (b) the inside diameter surfaces with cracking and (c) polished and etched cross sections of each wall. Specimen S-2 shows adiabatic shear bands and specimen S-3 shows ductile dimpled shear. The axial (A), hoop (H), and radial (R) directions are indicated.

Two specimens with different heat treatments are shown in Figure 2 after explosive expansion in the contained fragmenting round fixture. The effect of the tapered buffer layer, to produce an end-to-end strain gradient, is evident in Figure 2a. Cracking can be seen on the inside surfaces of the specimens (Figure 2b). These cracks, when viewed from the surface, appear the same for both hardnesses. Sections through the wall thickness reveal cracking at approximately 45° to the radial and hoop directions for both specimens (Figure 2c). However, there are clear differences in the deformation and fracture mechanisms of each specimen. Specimen S-2, the harder material, exhibits white layering with cracking along this surface. This is taken as direct evidence of adiabatic shear deformation and has been called transformation adiabatic shear.<sup>8,9</sup> This is in contrast to S-3, the softer specimen, in which there is no evidence of white layering nor deformation adiabatic shear bands (Figure 2c). Flow lines concentrating to a curved narrow band would be evidence of deformation adiabatic shear.<sup>8,9</sup> This division of adiabatic shear bands into two types was proposed on the basis of etching characteristics and hardness. There is, at this time, not enough crystallographic evidence to indicate that they are different structures. They could both be highly deformed matrix structures, and the degree of deformation alone would account for the etching and hardness differences.

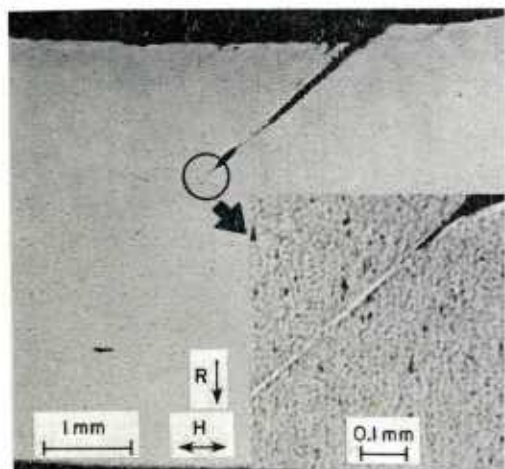
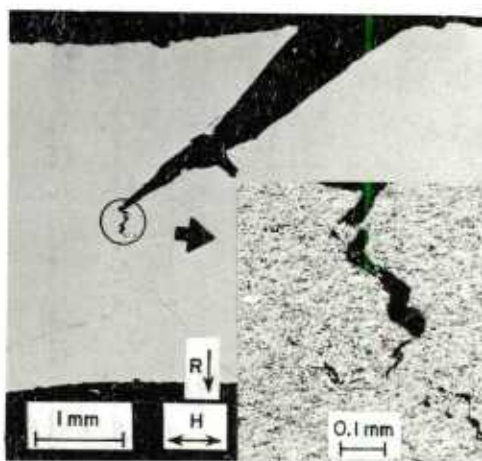
(c)

Specimen S-2 (Rc 43)

Specimen S-3 (Rc 27)

Fracture in S-2 was by cracking along adiabatic shear bands (determined by metallographic sections) and S-3 shows ductile dimpled shear cracking (determined by metallographic sections and scanning electron microscopy). As can be seen from Figure 2b, both modes of cracking appear the same on the surface and therefore distinction must be made by sectioning and metallographic examination.
